Salt Marsh Adaptation in the Narrow River

On Pettaquamscutt: Winter Speaker Series

Region-wide assessment of Narragansett Bay and RI South Shore salt marshes: 2012-2014

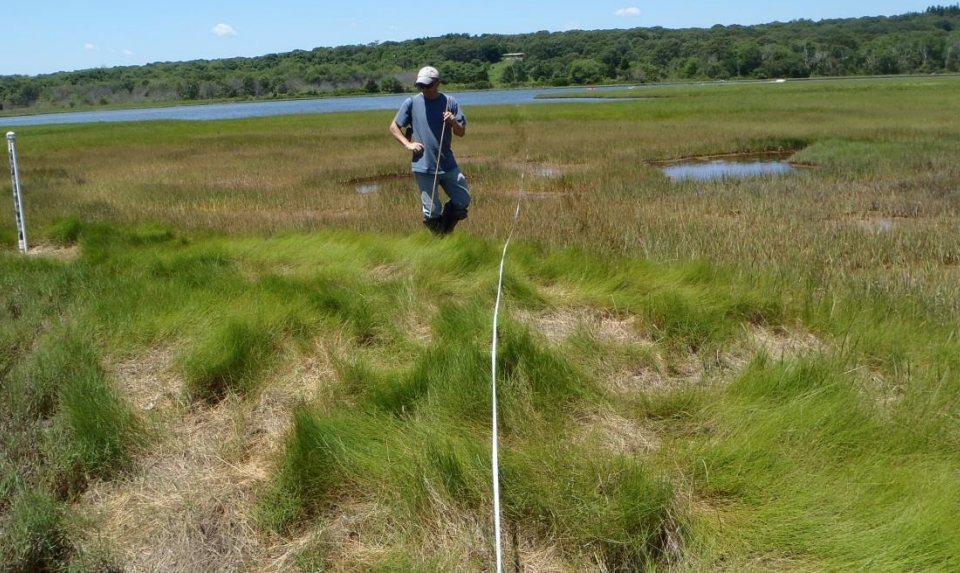
Belt Transect

- Monitored vegetation every 10 meters and width of plant communities
- Measured bearing capacity
- Additional data: salinity, mosquito density, fish presence

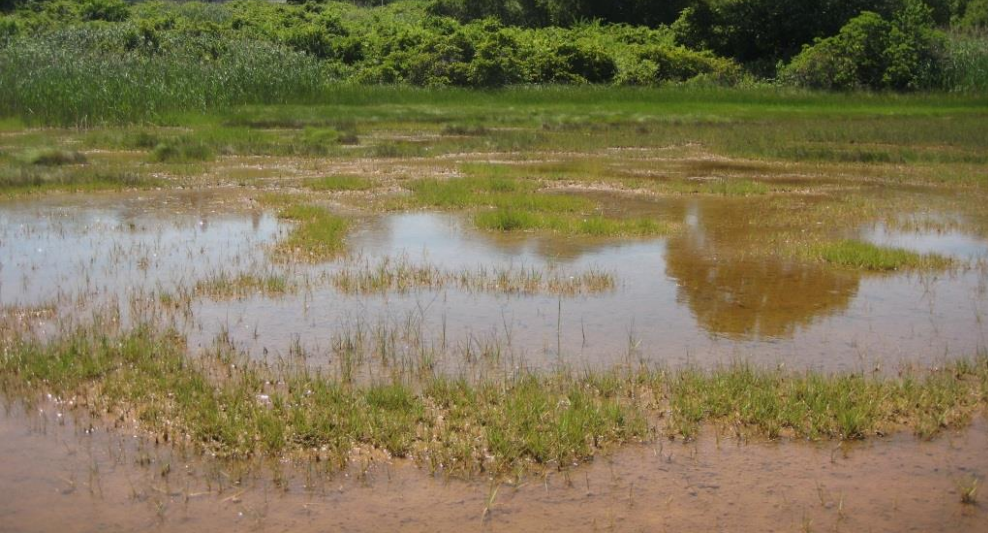
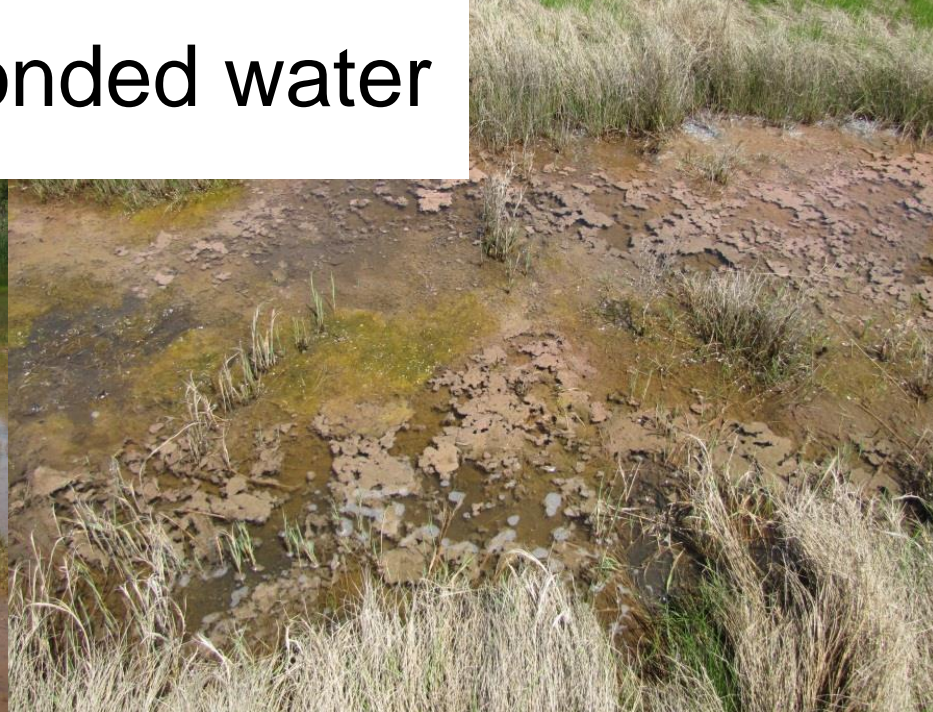
Shallow ponded water

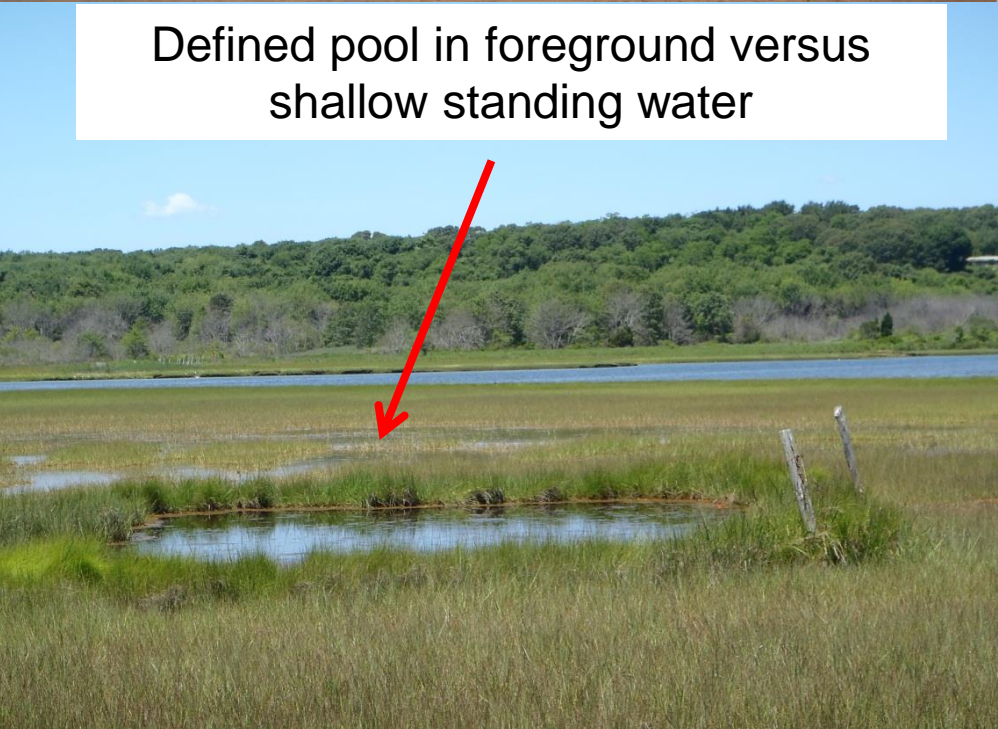
Defined pool in foreground versus shallow standing water

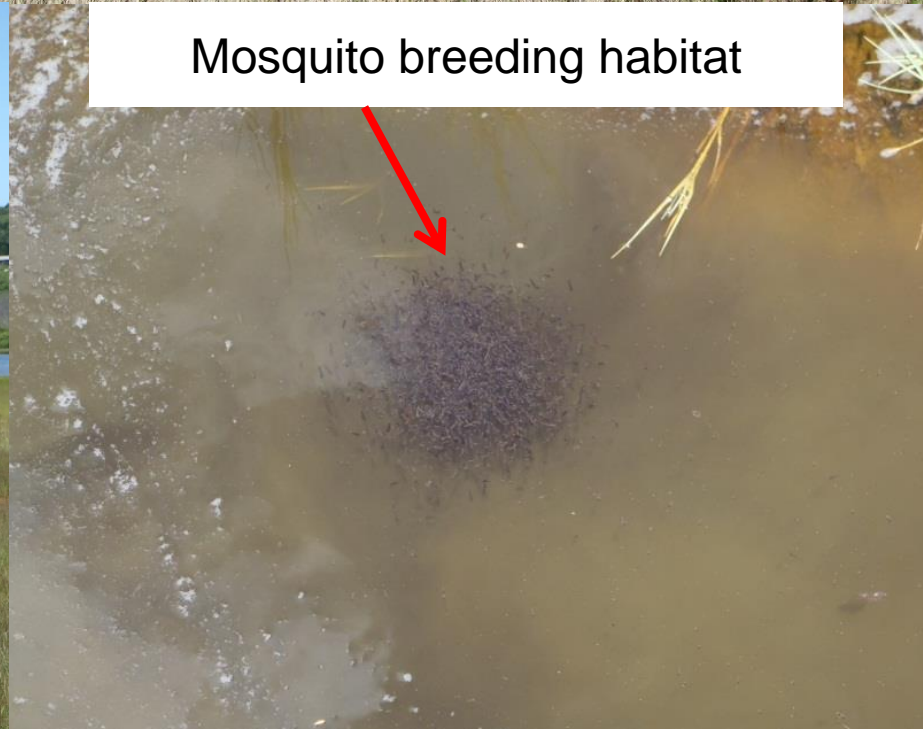
Mosquito breeding habitat

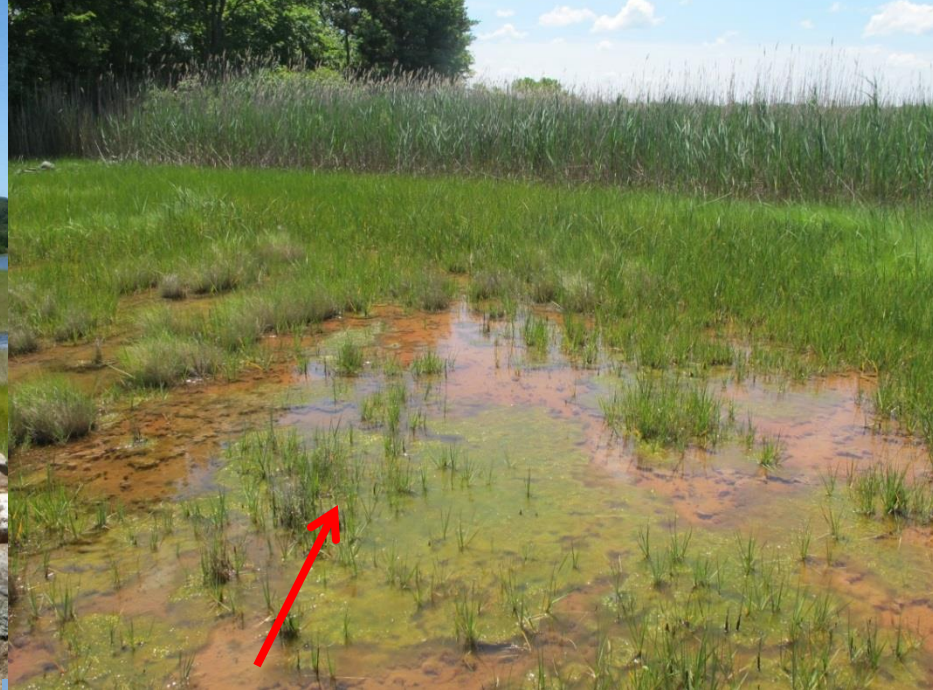
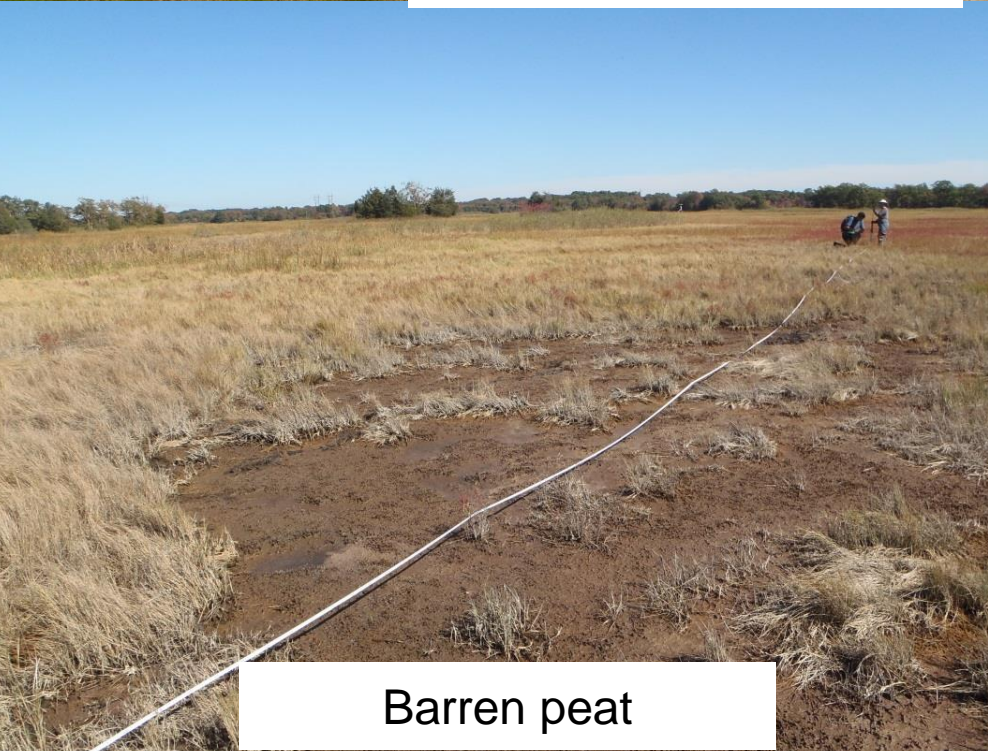
Narrow high marsh
along upland edge

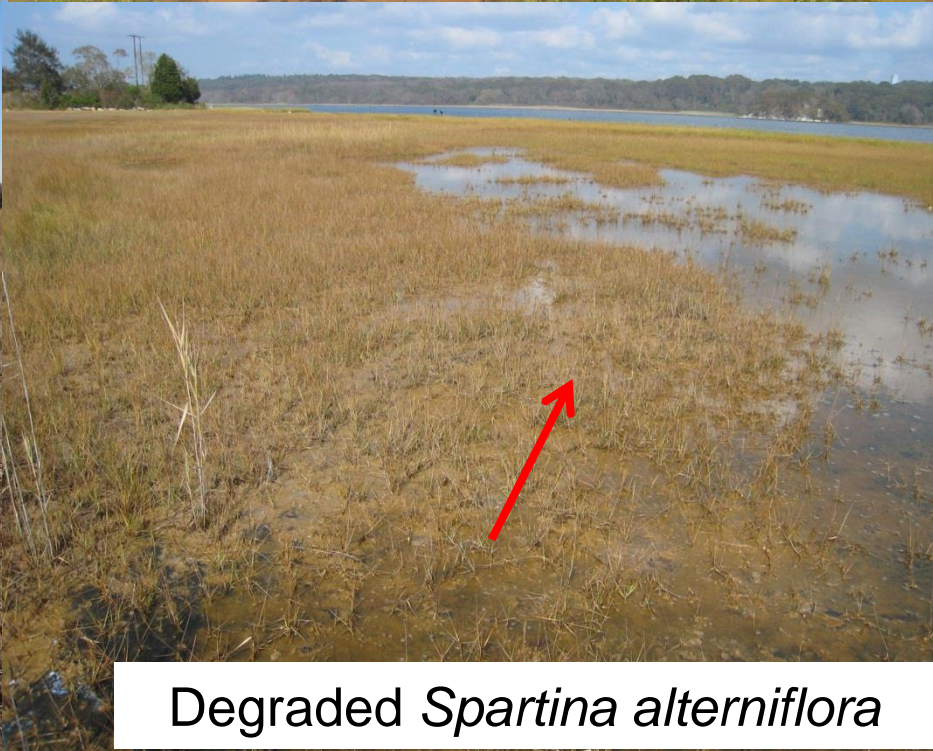
Barren peat

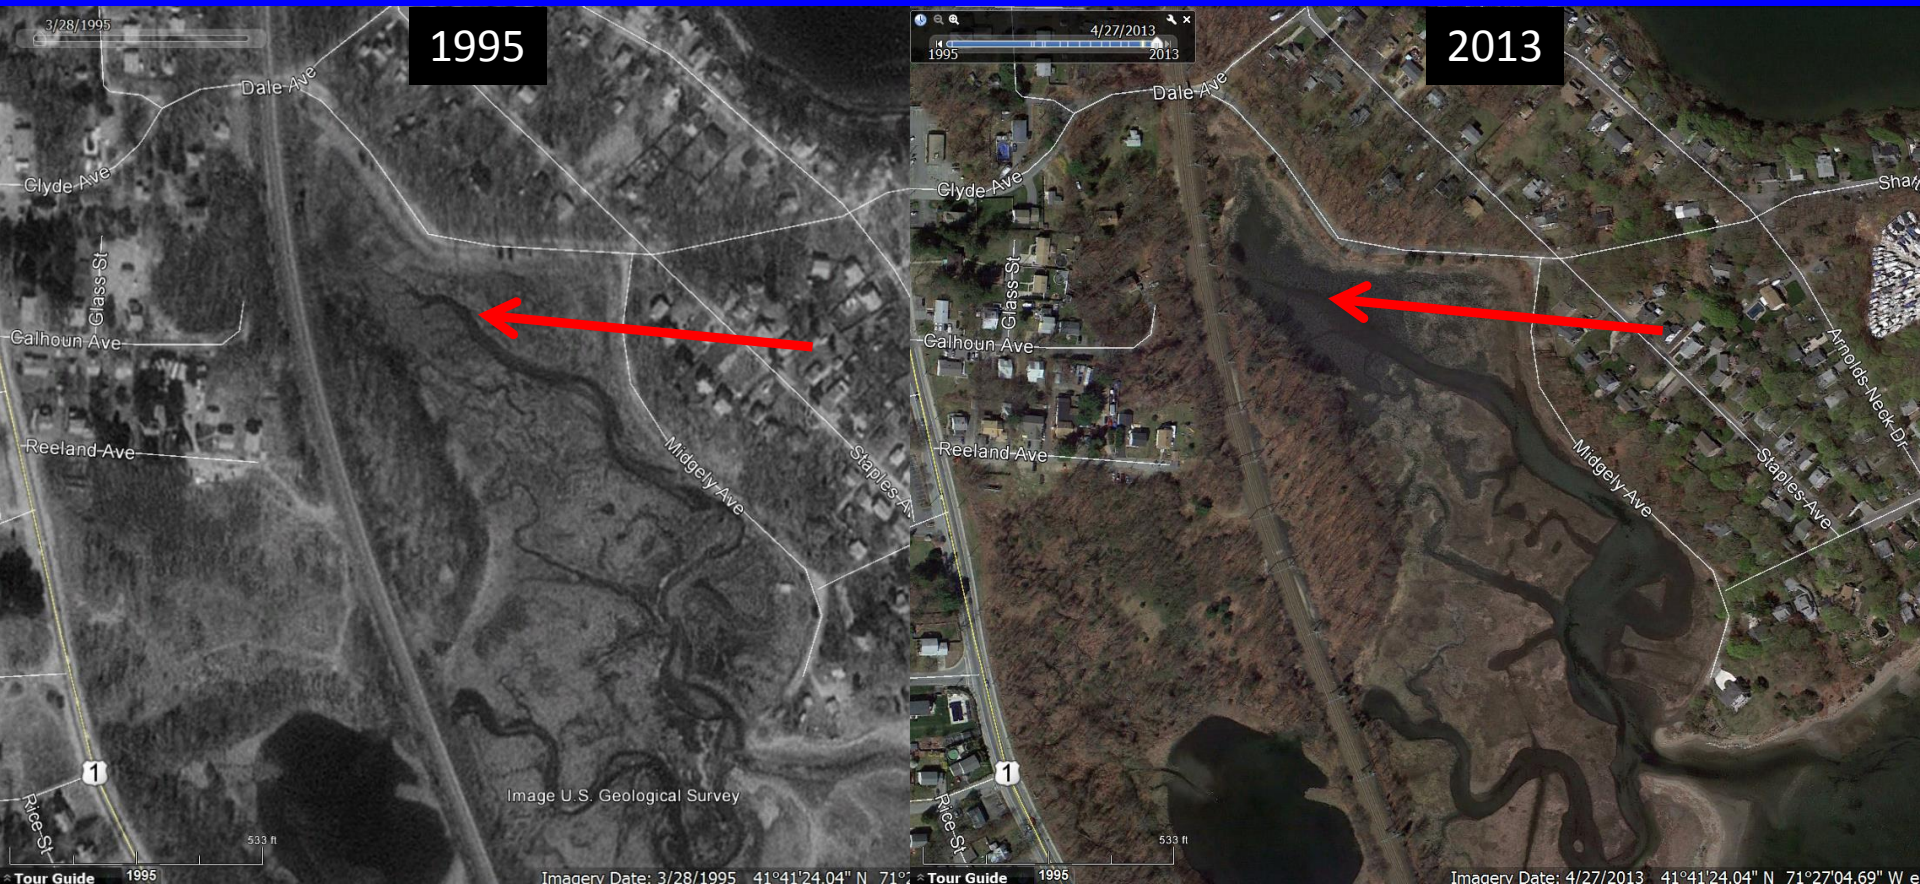
Marsh Loss: Mary's Creek, Warwick

1995-2013

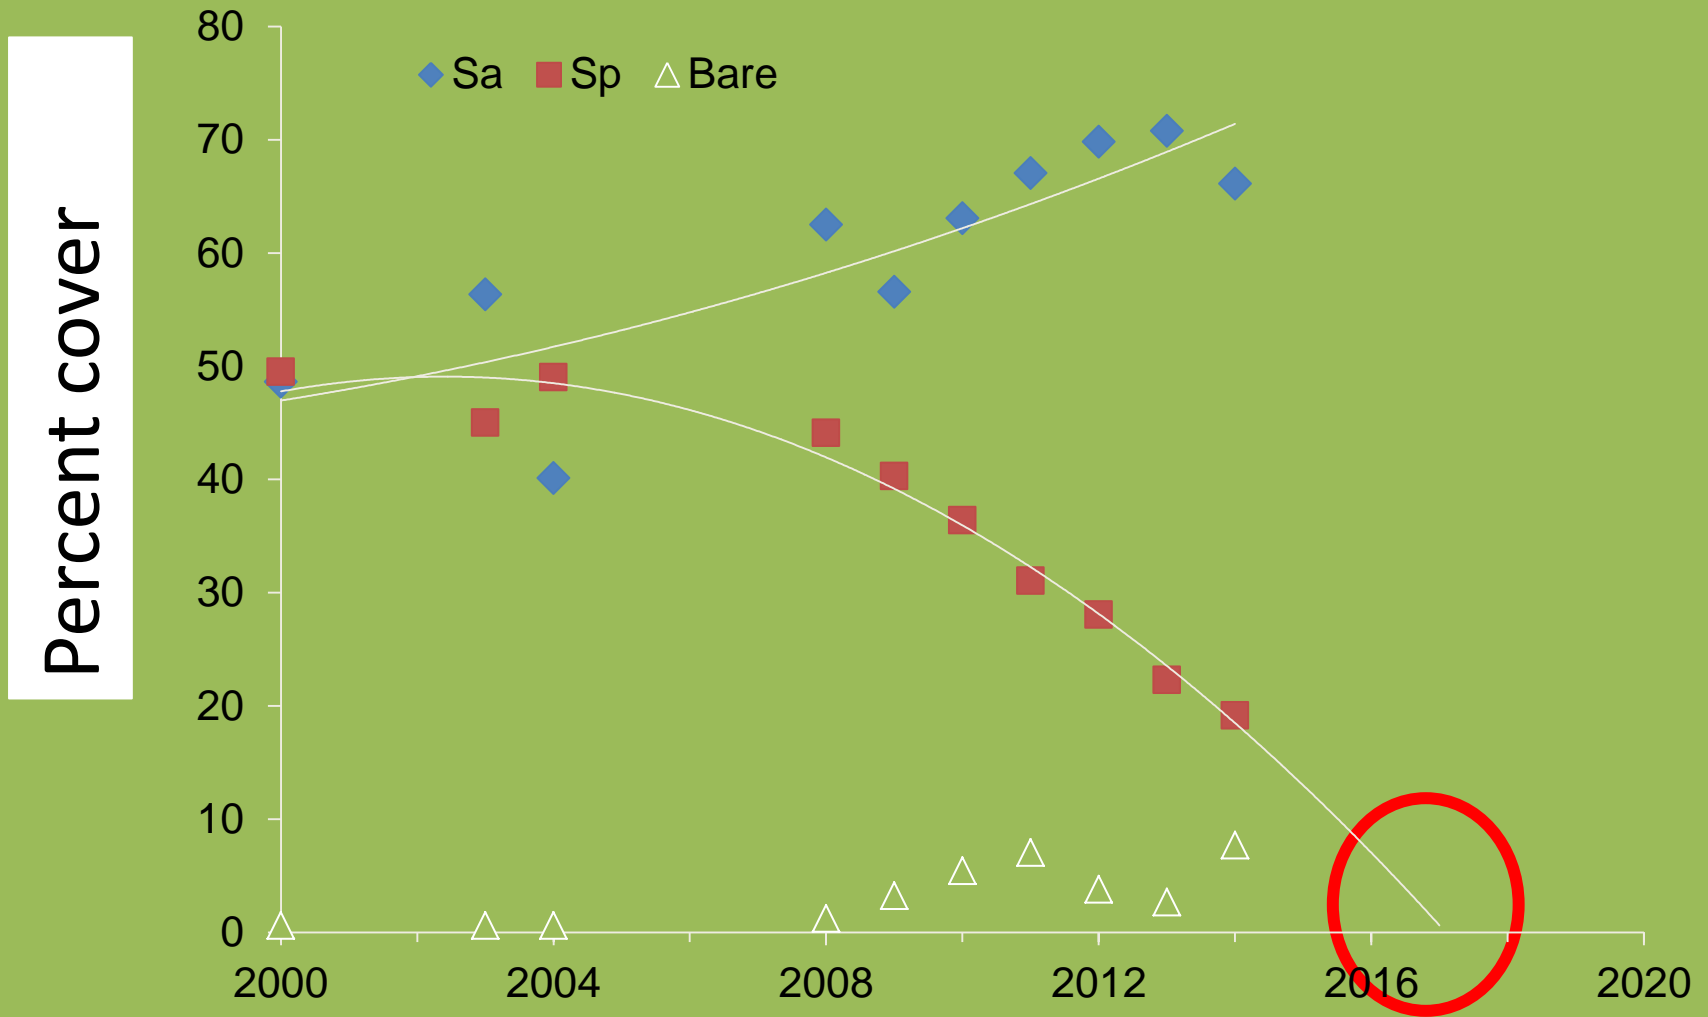
Coggeshall Marsh: Rapid loss of *Spartina patens*

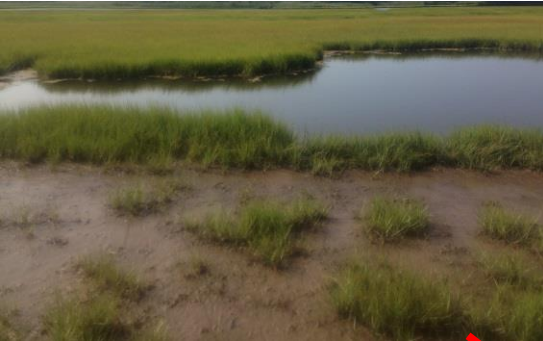
Southwest Pettaquamscutt Cove

Ponded water adjacent to pool:
unstable peat/bog-like conditions

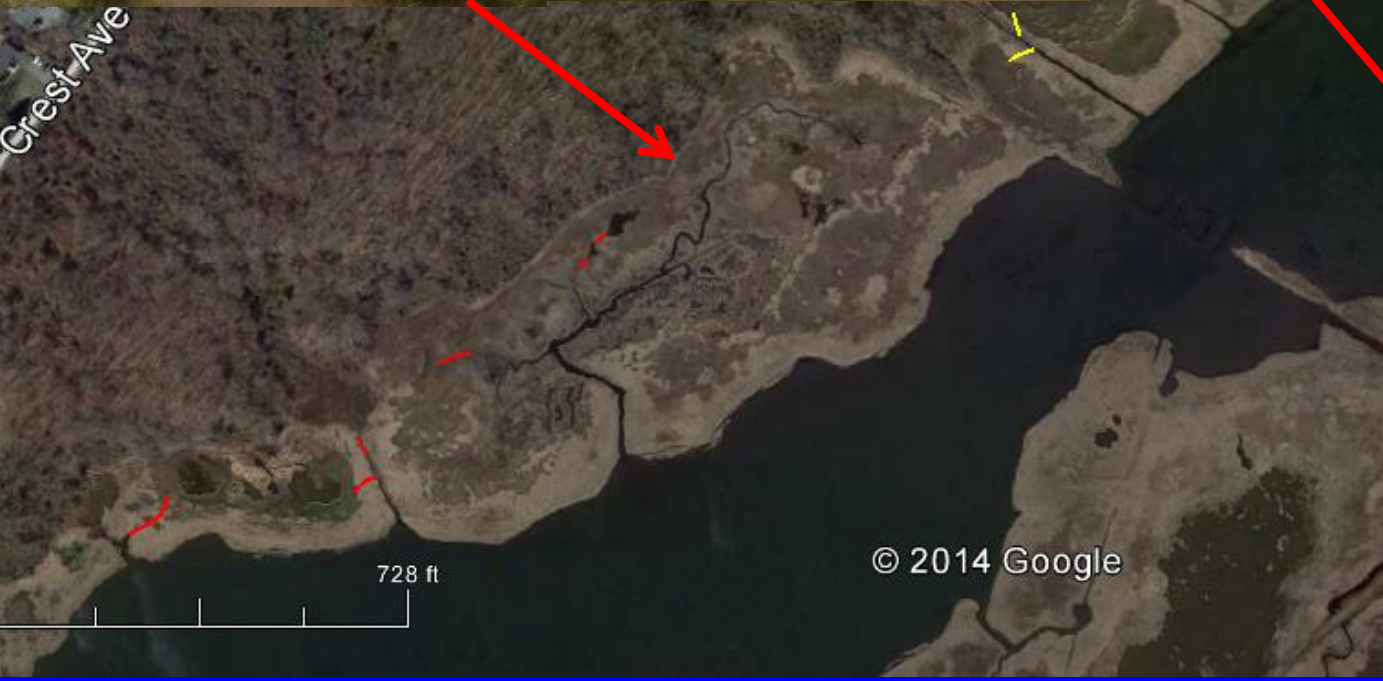
Historic pools expanding onto
marsh surface

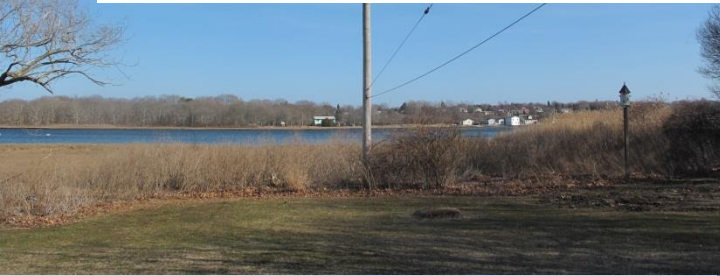
Potential end of road retrofit: Ash Street

Opportunity for pavement removal and creation of area for runoff infiltration

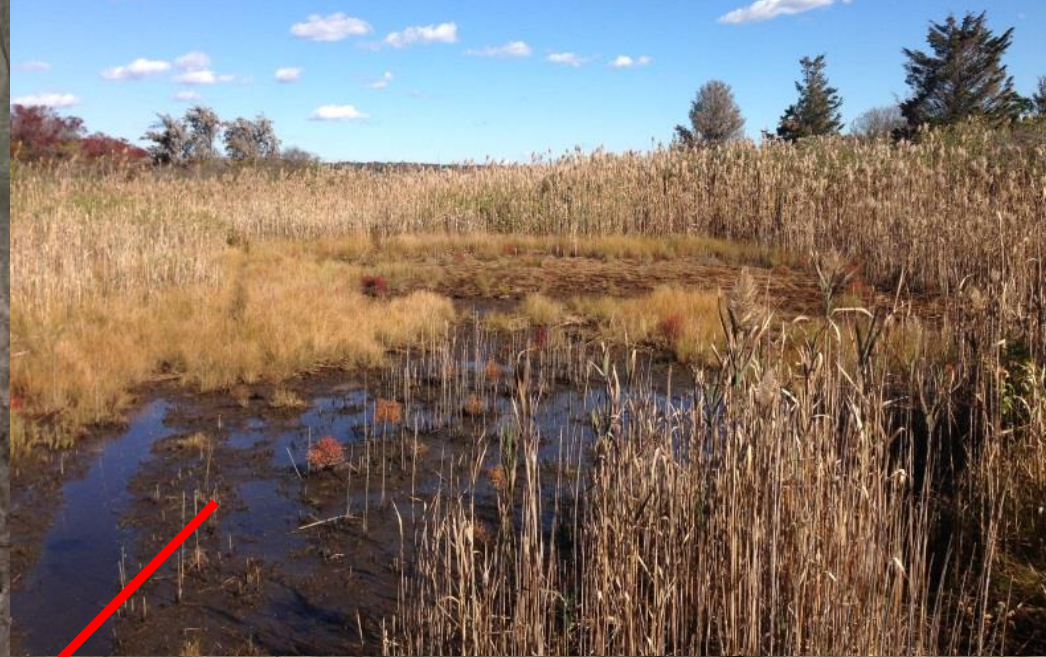
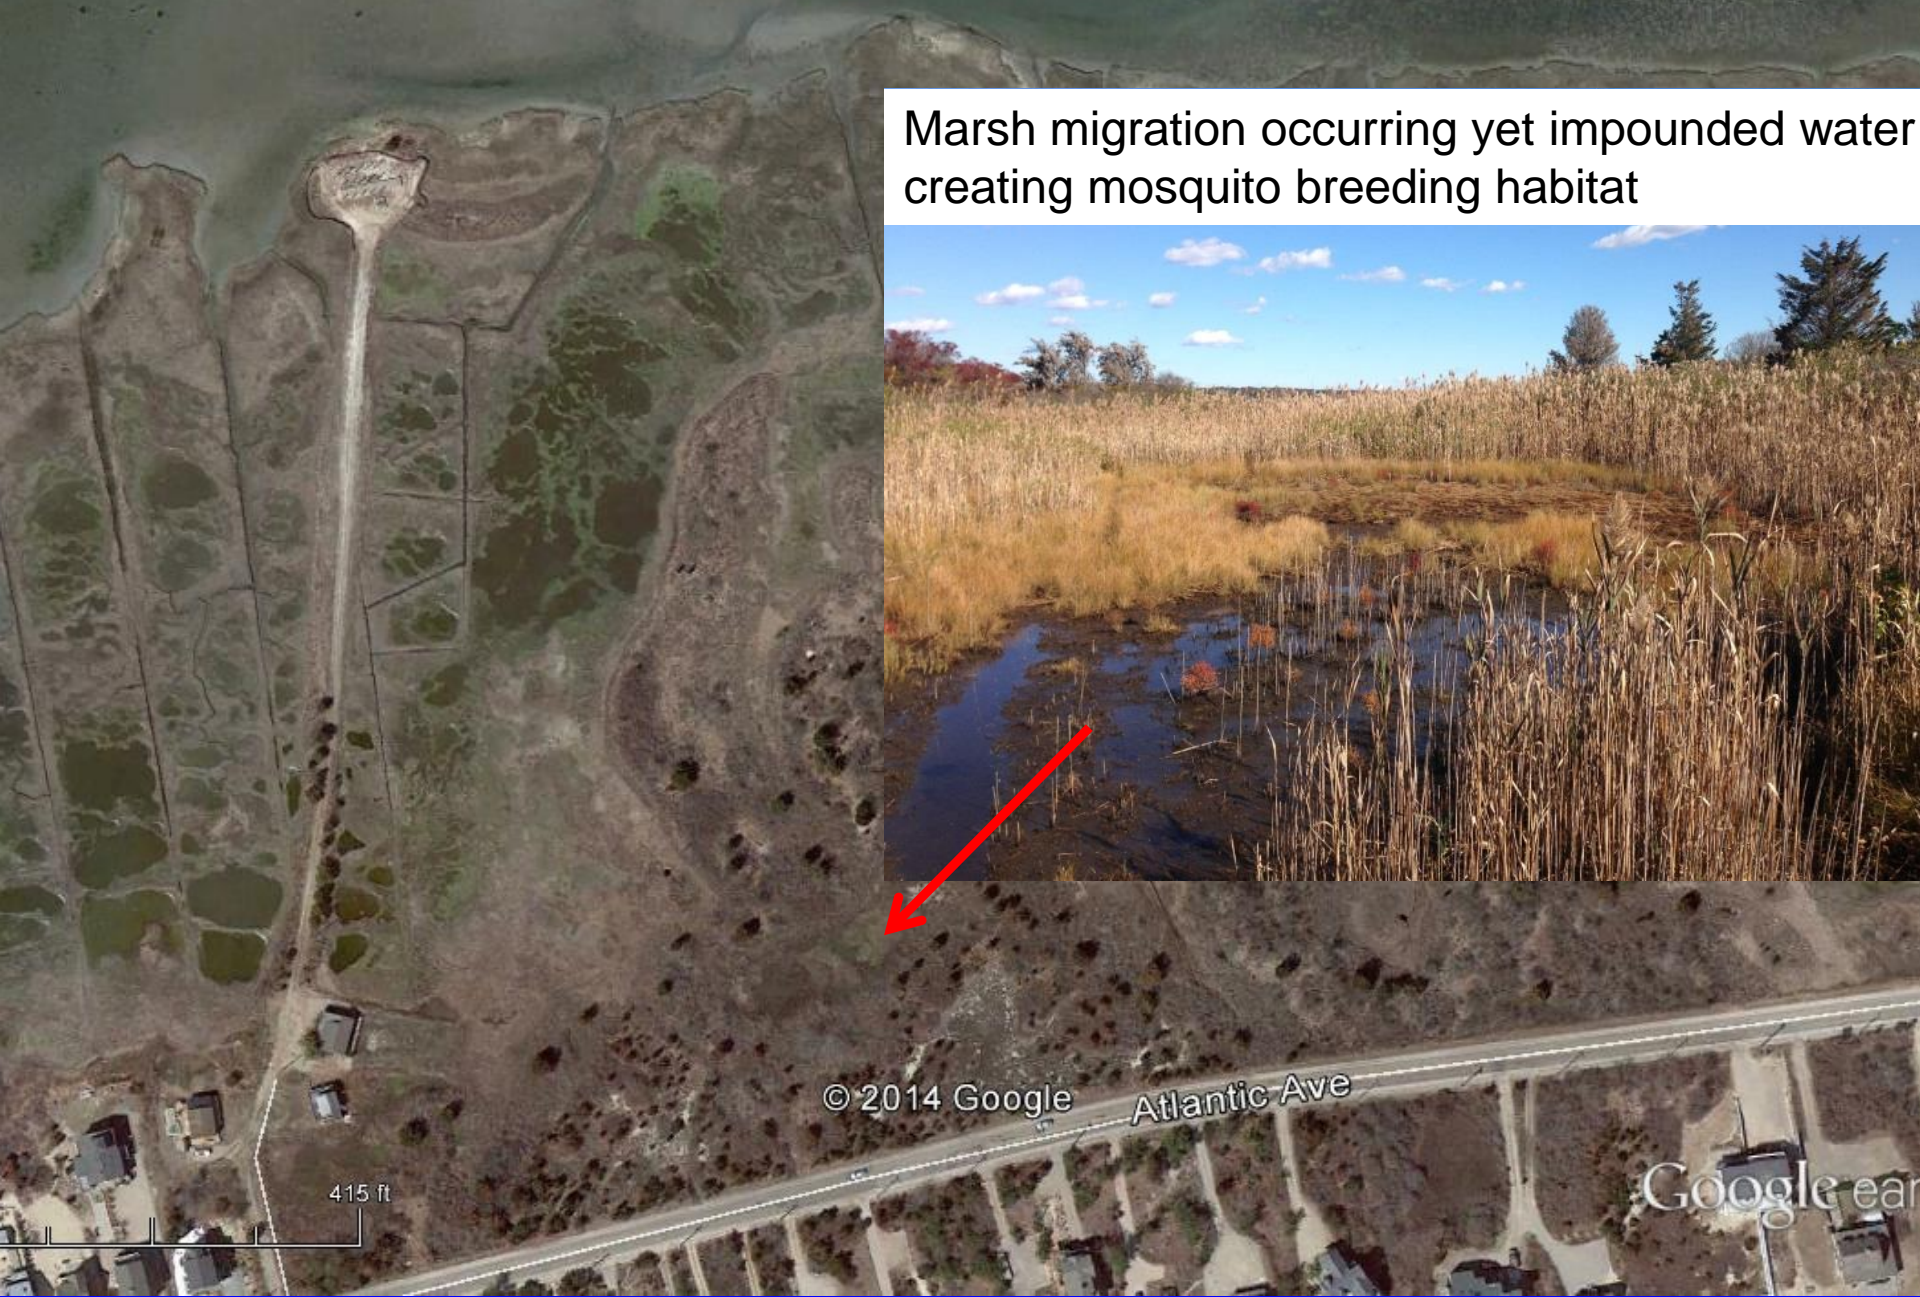
Winnapaug Pond Marsh

Marsh migration occurring yet impounded water creating mosquito breeding habitat
