# An Overview of Hurricane Sandy Resiliency Restoration at the John H. Chafee NWR, Rhode Island

Nick Ernst, USFWS

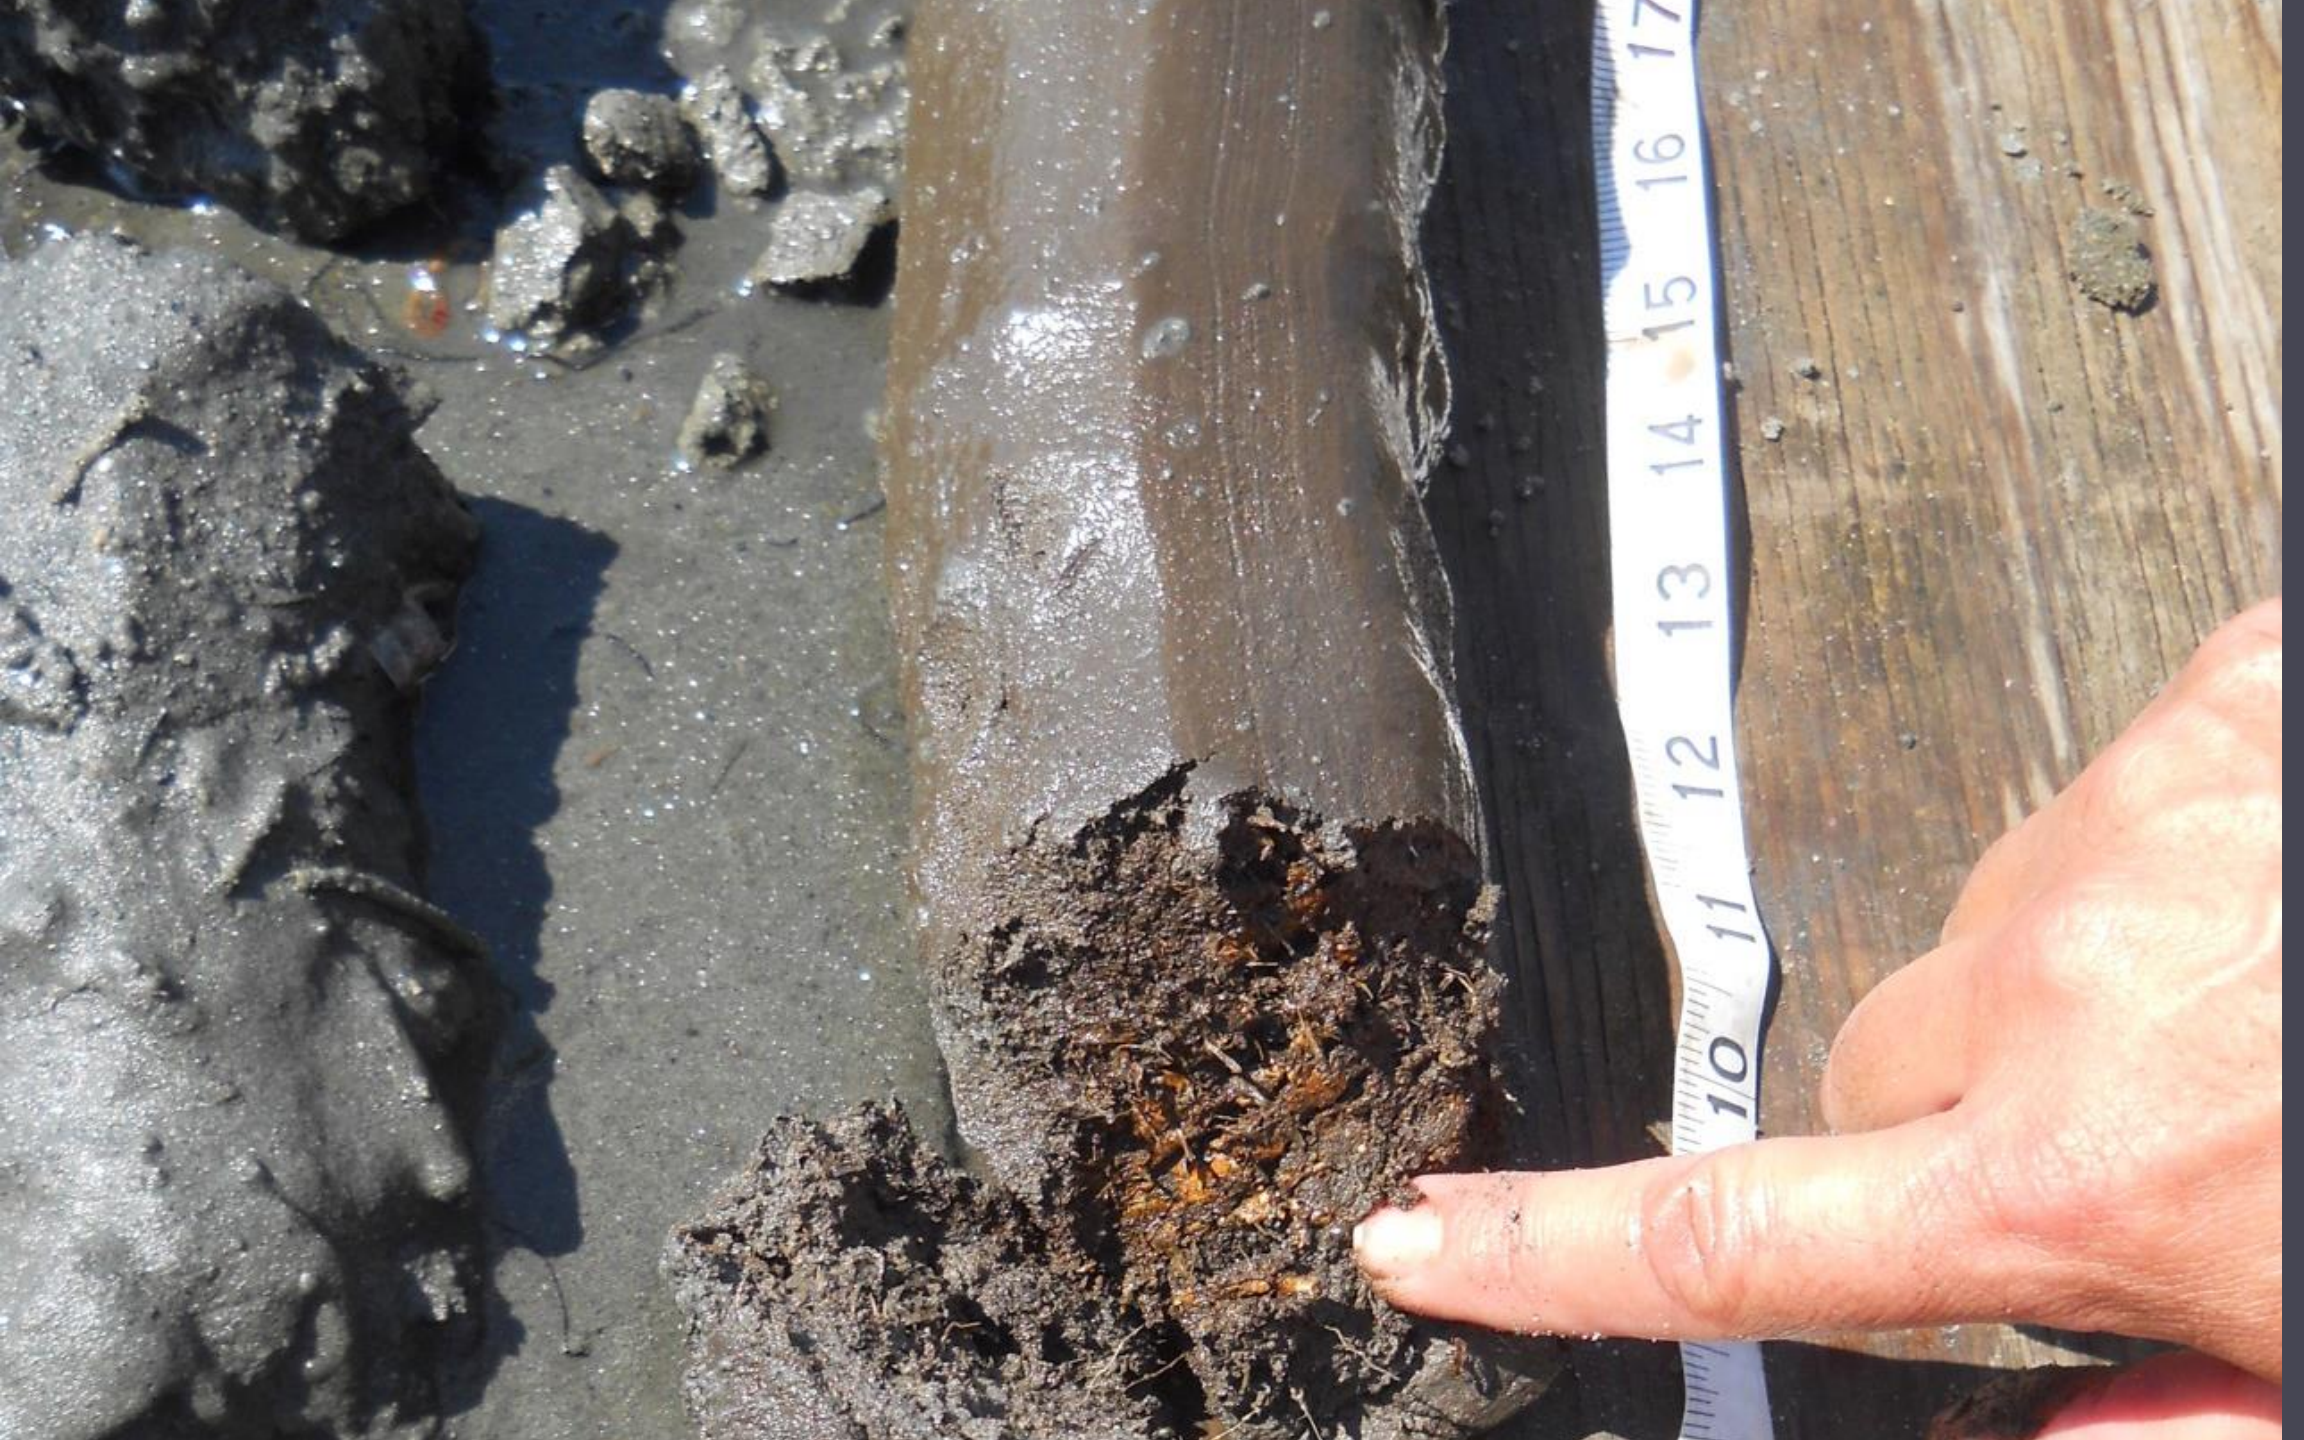
DEPTH (INCHES)	PERCENT FINES BY SAMPLE AND STRATA				
	S1	S2	S3	S4*	S5*
0					
5	2	13.2			
10			3.8	14.1	23.7
15	17.5	52.2			
20					41.9
25					
30		23.2		19.9	
35	10.3		4.2		47.7
40		19.1			
45	4	8.3		4.1	
50			2.8		
55					
60				2.6	
65					60.1
70			29.1		
75					
80					5.7
85					
90				15.6	
95					
100					
105

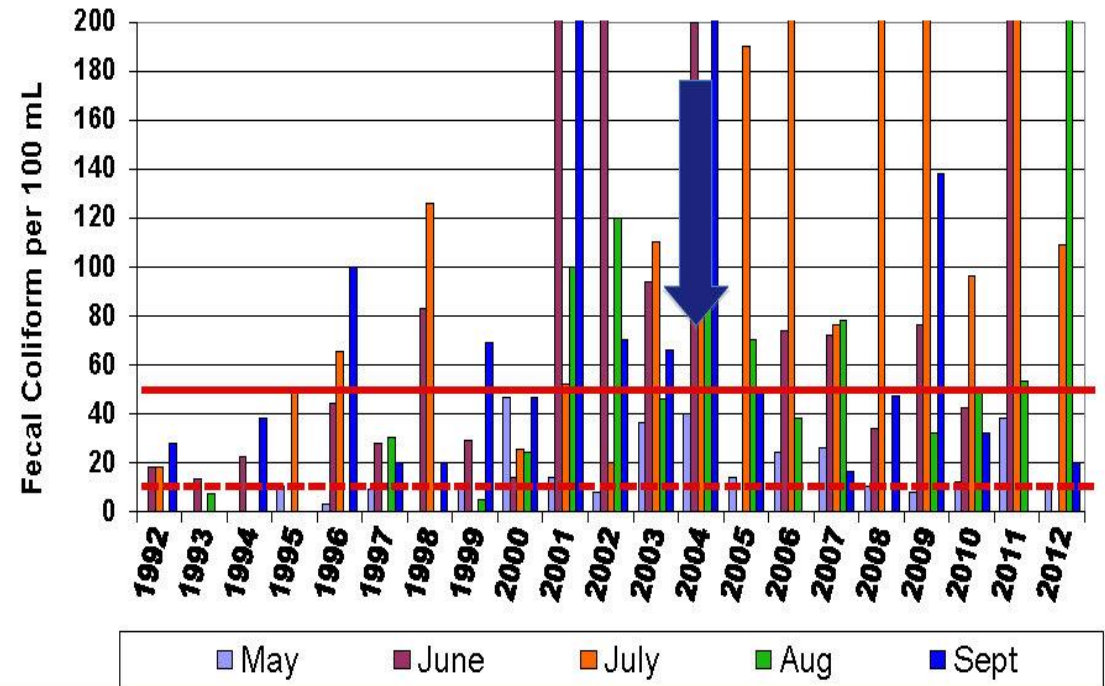
### NR-8: Bacteria - Fecal Coliform

## NR-8: Middlebridge

— Safe Swimming = 50 FC/100 mL  
- - - Shellfishing = 14 FC/100 mL

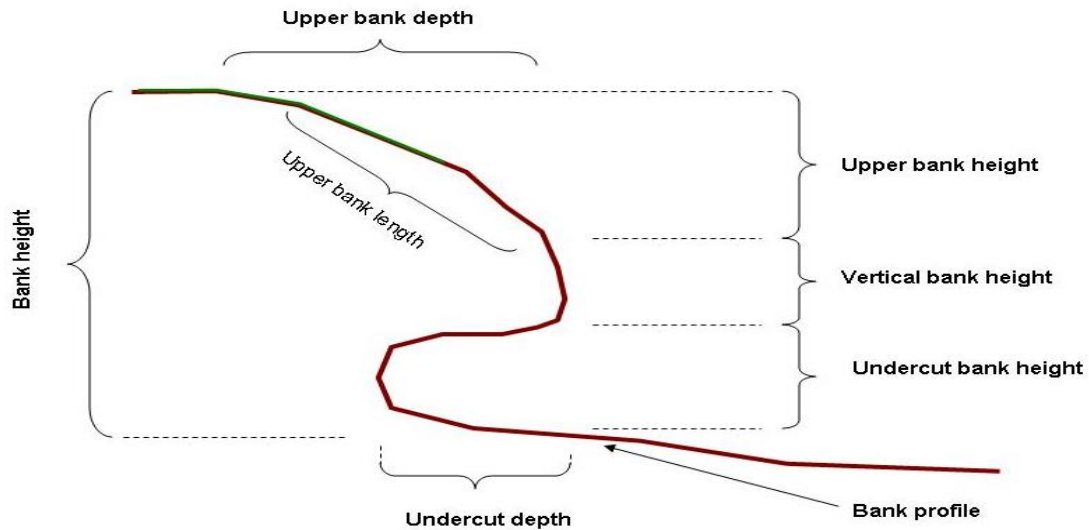
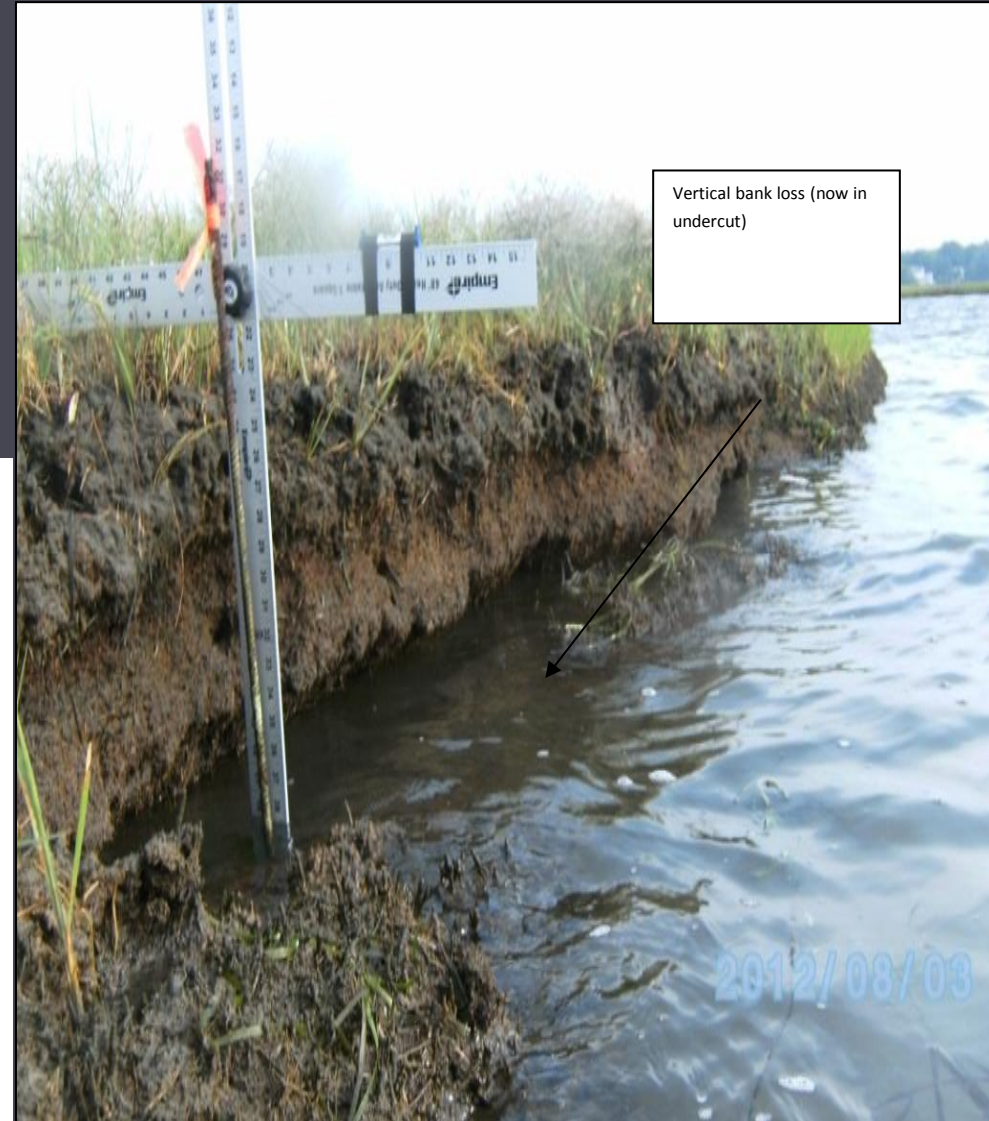
- Unstable Banks
  - Throughout Narrow River
  - Sections of saltmarsh slump into river
  - Wind driven waves, boat wakes, green crabs

Cross sectional view of typical saltmarsh riverbank, Lower Narrow River

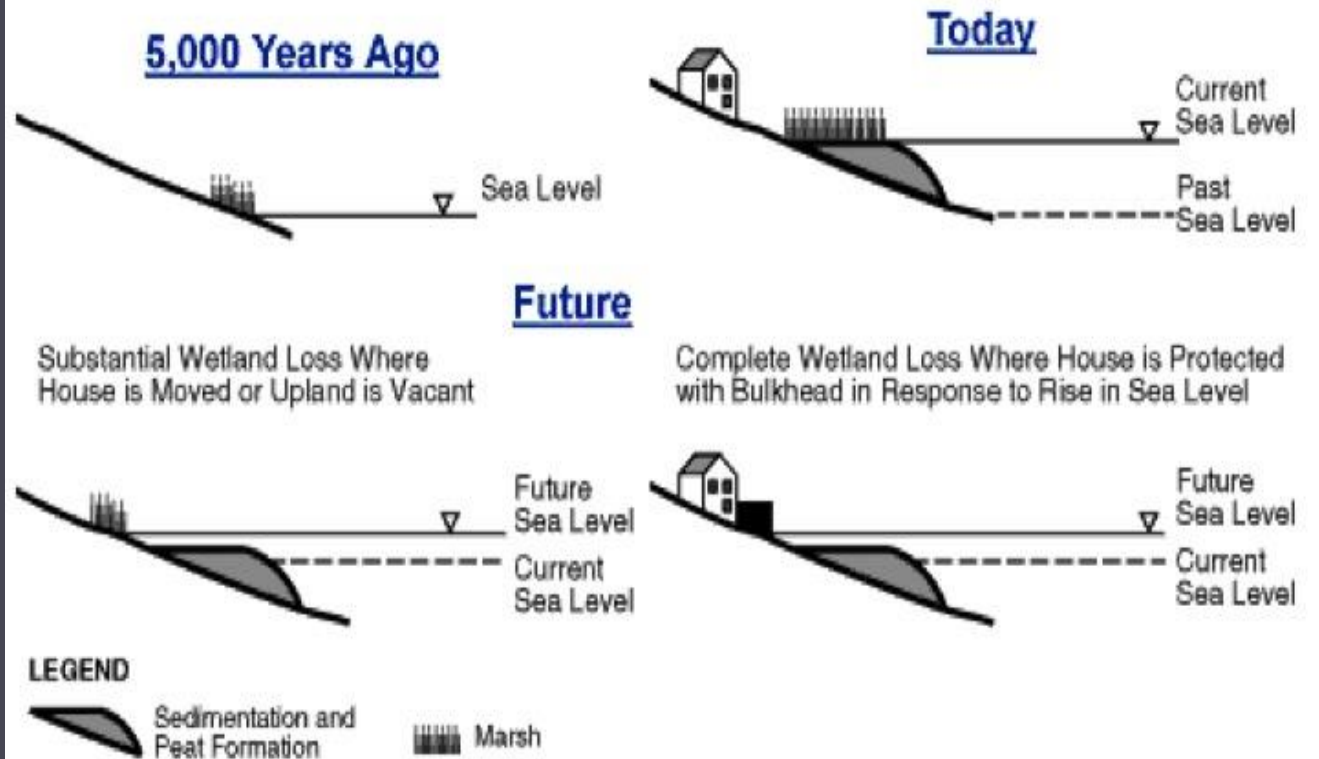
- Saltmarsh elevation growth about 2–3mm/year (accretion)
- Sea level rise (SLR): 4 mm/year
- SLR outpacing marsh growth

## Evolution of a Marsh as Sea Level Rises

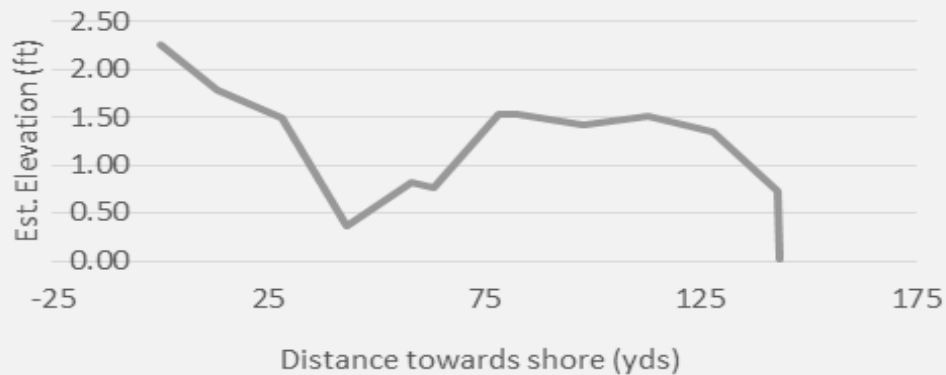
Saltmarsh Surface Profile Unit PC02, T10

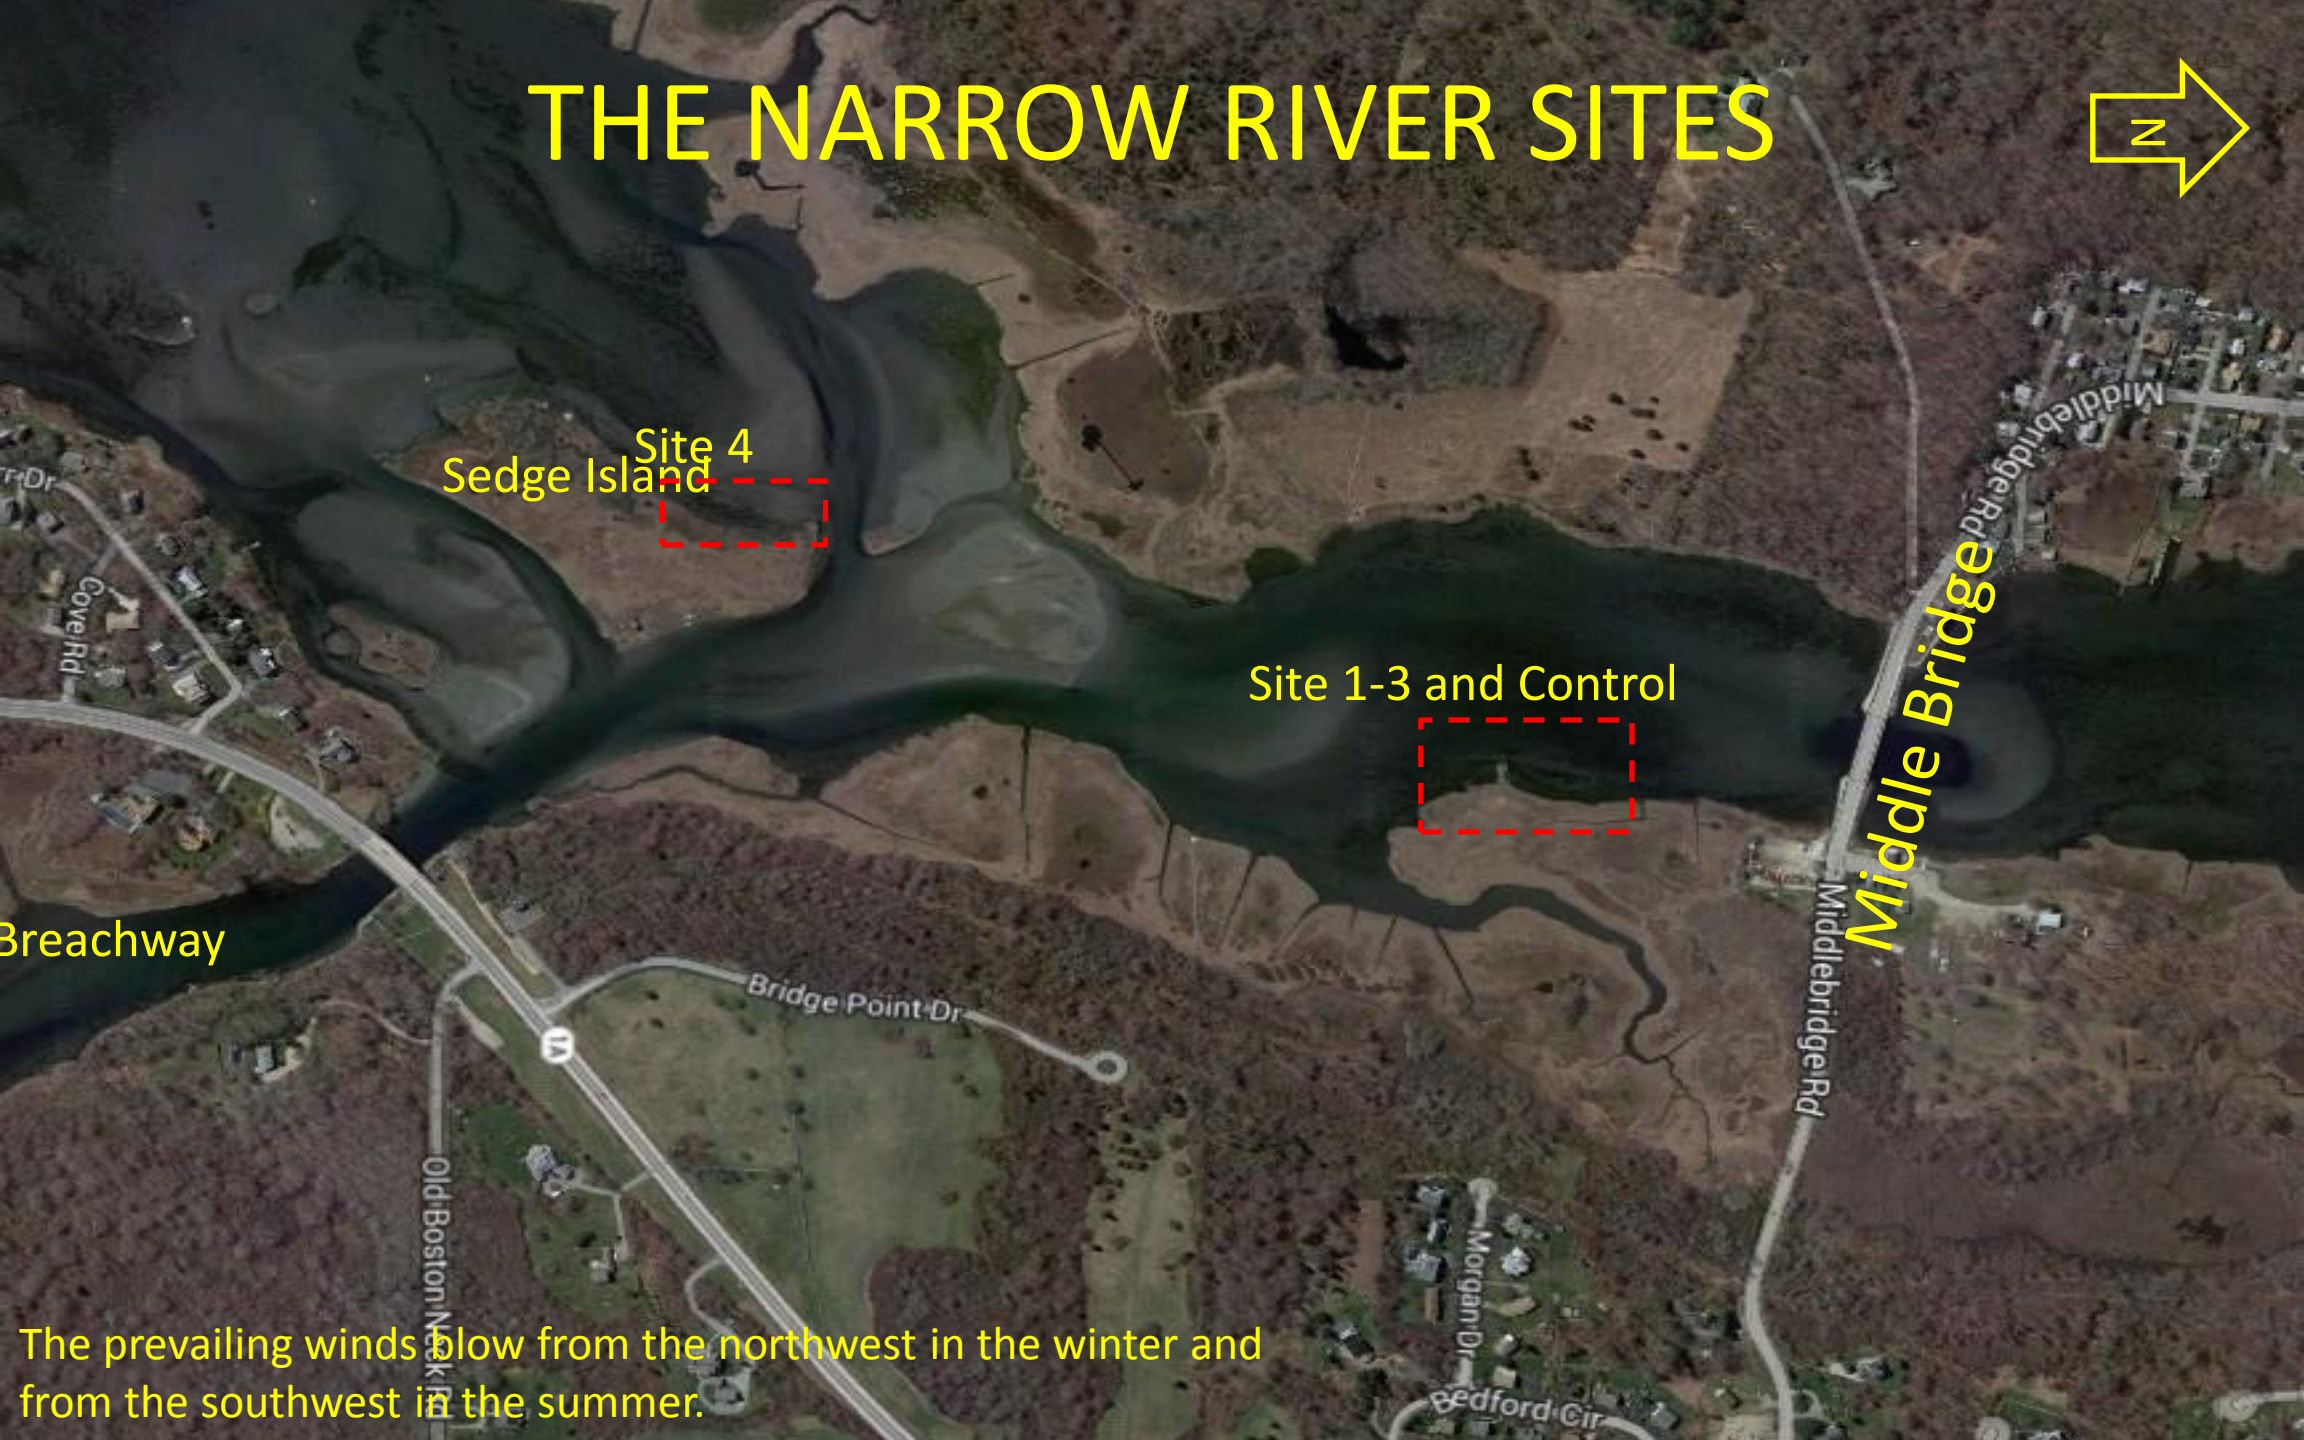
# THE NARROW RIVER SITES

The prevailing winds blow from the northwest in the winter and from the southwest in the summer.

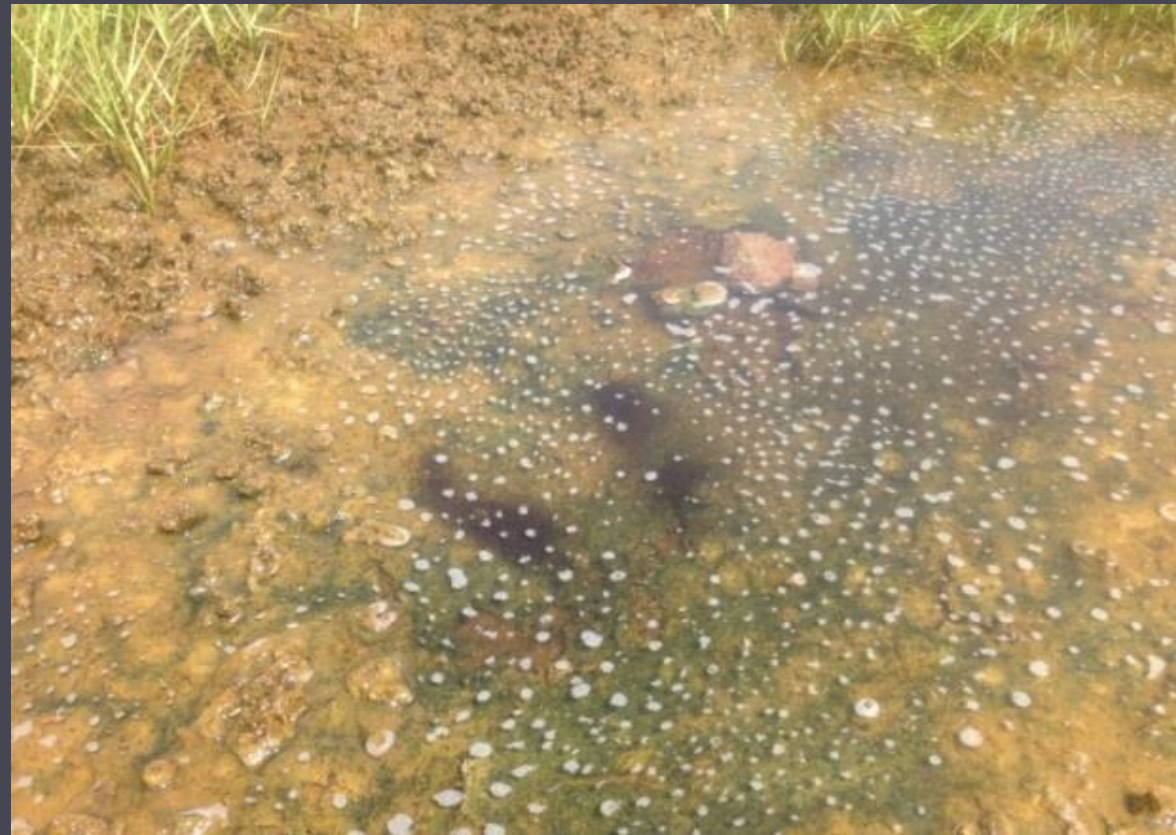
**RUNNELS:** Excavate shallow channels ,8–12” deep, 2’ wide

- Restore growing conditions for marsh vegetation
- Provide surface drainage
- Enhance habitat for small estuarine fish
- Enhance high marsh nesting habitat
- *Reduce mosquito breeding habitat*

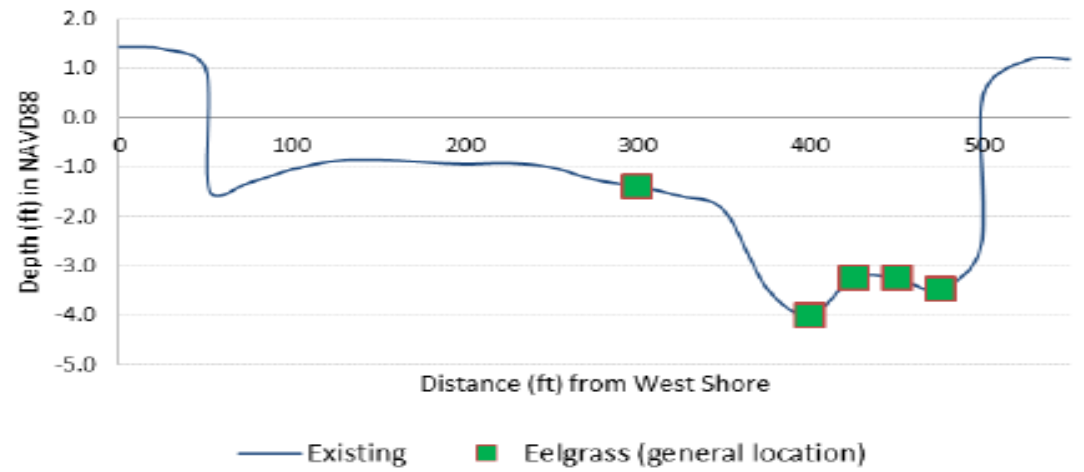
Bottom Profile, Narrow South (T1) September, 2014

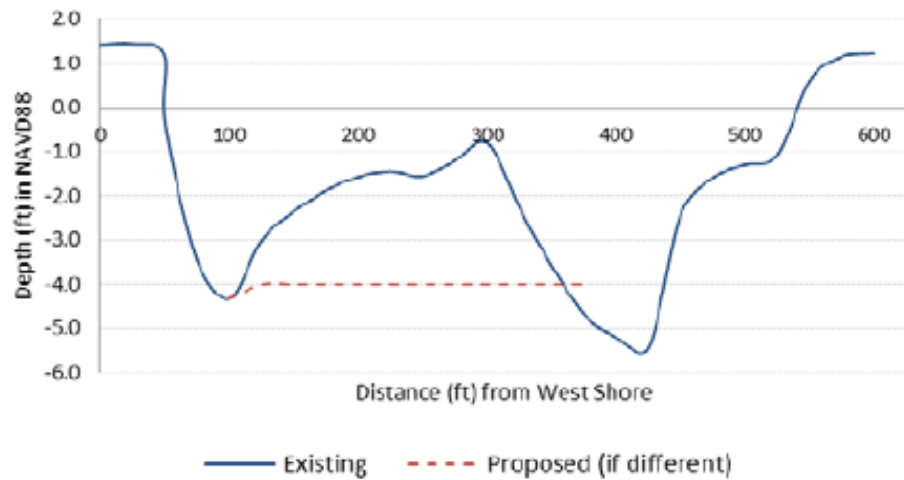
Bottom Profile, Narrow South (T4) September, 2014

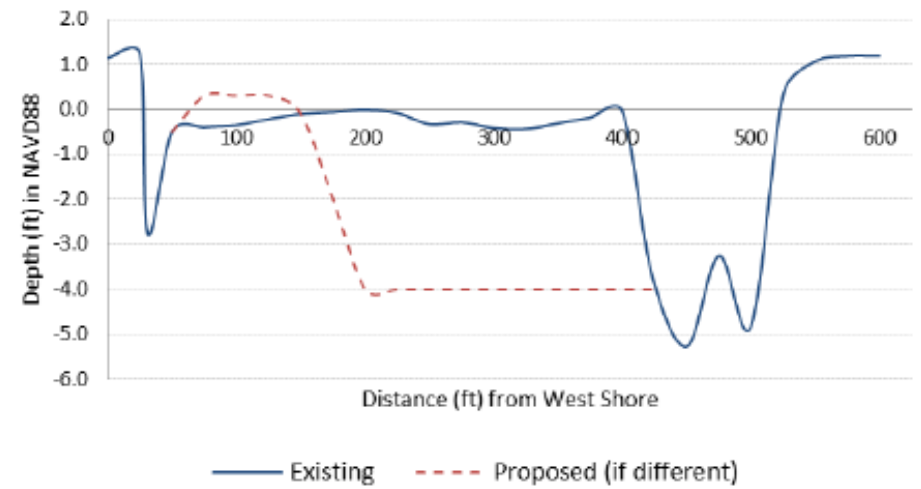
Bottom Profile, Narrow South (T3) September, 2014
